**Abraham Lincoln Capital Airport (SPI)
Springfield, Illinois
Runway Safety Bulletin**

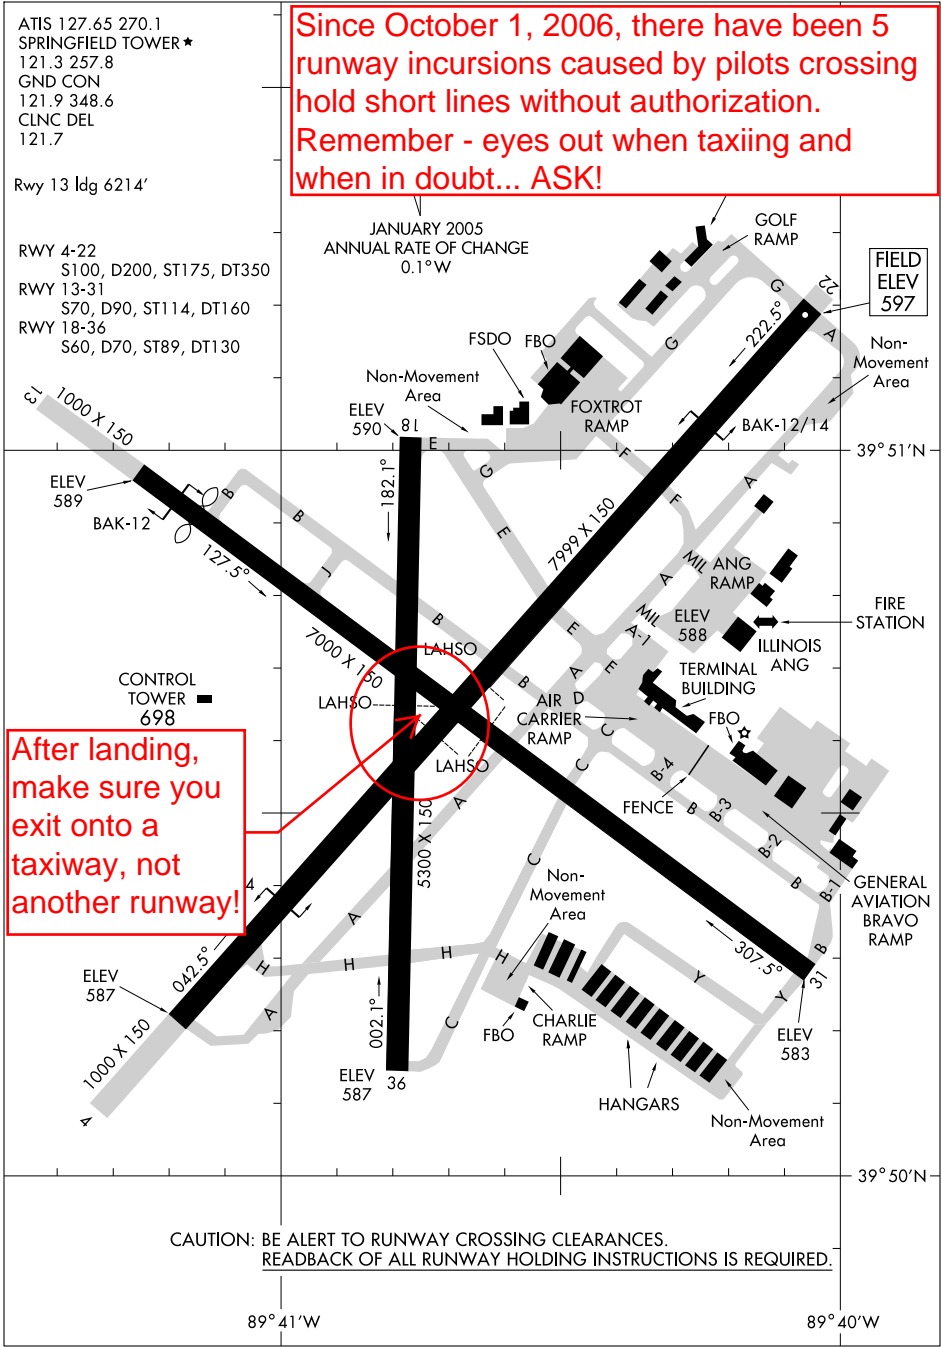
AIRPORT DIAGRAM

Since October 1, 2006, there have been sixteen (16) surface incidents at Abraham Lincoln Capital Airport (SPI). Fifteen (15) events were classified as runway incursions. Nine (9) incursions resulted from pilot deviations. Five (5) pilot deviations involved pilots crossing runway hold short lines without authorization.

- Three (3) incidents involved landing aircraft that turned onto a runway instead of the assigned taxiway.

Since October 1, 2006, there have been 5 runway incursions caused by pilots crossing hold short lines without authorization. Remember - eyes out when taxiing and when in doubt... ASK!

After landing, make sure you exit onto a taxiway, not another runway!

Warning: Pilots taxiing aircraft must use caution due to numerous taxiway and runway intersections in close proximity. Watch for runway holding position markings and signs, and taxiway location signs to help maintain situational awareness. If in doubt... ASK!

Warning: Pilots of landing aircraft must use caution not to exit onto an intersecting runway. Three runways intersect at midfield. Watch for runway exit signs that identify intersecting exit taxiways to help maintain situational awareness. If in doubt... ASK!
